Assessment of Curlyleaf Pondweed Turion Distribution & Abundance in the Red Cedar Chain of Lakes

Red Cedar Lake – Barron County, WI (#2109600)

Surveyed October 25, 2021

Prepared for the Red Cedar Lakes Association (Mikana, WI) – November 2021

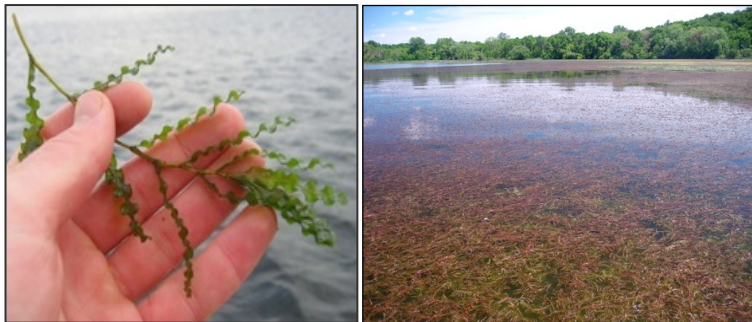
Figure 1. Close-up showing wavy leaves typical of mature curlyleaf pondweed (left), and an image of dense, surface-matted curlyleaf growth in a heavily-infested lake (right).

Curlyleaf pondweed (*Potamogeton crispus*) is an invasive aquatic plant that typically forms dense surface growth (Figure 1) and displaces native aquatic plants (Madsen and Crowell 2002). Consequently, it has dramatically reduced the recreational and ecological quality of many lakes in the upper Midwest (Catling and Dobson 1985, Bolduan et al. 1994). Curlyleaf's ability to dominate the plant community in lakes is enhanced by its novel life-cycle (Figure 2, Tobiessen and Snow 1984). Although it is considered a perennial species, it behaves as a winter annual in northern lakes (Netherland et al. 2000, Madsen and Crowell 2002), sprouting from turions (reproductive buds) in the fall, persisting as small shoots under the ice during the winter, growing rapidly in the early spring (Kunii 1982, Tobiessen and Snow 1984), and forming dense surface growth and new turions in May and June (Wehrmeister and Stuckey 1992, Bolduan et al. 1994). Curlyleaf plants typically die off by mid-summer and deposit any newly-produced turions to the lake sediments. Although this means that the dense matted curlyleaf growth is generally short lived and disappears in the early summer, the turions that were deposited to the lake sediments lead to new curlyleaf growth in the subsequent years. Although curlyleaf also produces seeds, under most conditions its annual life-cycle is thought to be almost entirely dependent upon sprouting from turions in lake sediments (Rogers and Breen 1980, Sastroutomo 1981, Bolduan et al. 1994). Consequently, there has been great interest in adopting management strategies that can prevent turion production, deplete accumulated turions, and thus decrease nuisance growth.

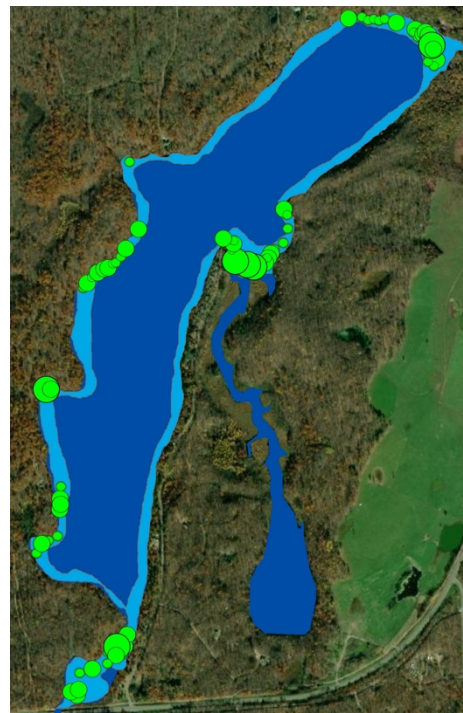
Figure 5. Maps showing the littoral area of each lake (light blue; ≤ 15 ft), and the locations where we found curlyleaf pondweed during the June 2021 surveys of Balsam, Hemlock, and Red Cedar Lakes. Density based upon number of stems retrieved on rake.

- Low (1-3 stems)
- Medium (4-10 stems)
- High (>10 stems)

Freshwater Scientific Services conducted a lake-wide search for curlyleaf pondweed on June 3, 2021, with a focus on those areas that had supported curlyleaf growth in the past. During this survey, we navigated a winding search path over nearshore areas while using a combination of surface observations, rake tosses, and sonar readings to locate any areas of curlyleaf. For locations where we found curlyleaf, we recorded the GPS location, water depth, and curlyleaf growth density (0 to 3 scale based upon stem density). These recorded locations and site data were entered into desktop GIS software for detailed mapping of curlyleaf beds (Figure 5).

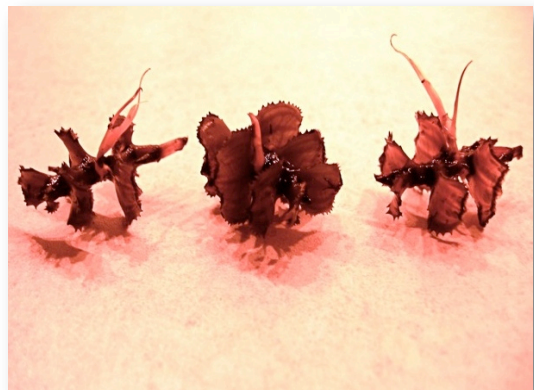
Figure 6. Ponar sediment sampler (Wildlife Supply Company; Yulee, FL), sifting bucket, and a collected sediment sample for turion assessment (left); close-up of sprouting turions collected from lake sediments (below).

Staff from Freshwater Scientific Services collected sediment samples at all 170 sample locations (Figure 7) on October 25, 2021. At each location, we collected one sediment sample using a petite Ponar dredge (225 cm² basal area). Upon retrieving each sediment sample, we removed any material from the outside of the closed dredge, emptied the sampler contents into a sifting bucket (1-mm screen), and gently sifted the sample to remove fine sediment (Figure 6). The contents remaining in the bucket after sifting were placed into a labeled plastic bag and stored in a cooler while in the field. In the lab, we manually sorted turions from other debris and recorded total turion counts for each sample. Small turion fragments (those that did not include a portion of a central turion stem) and severely decayed turions (those that did not retain their shape when lightly squeezed) were discarded and were not included in the final turion counts.

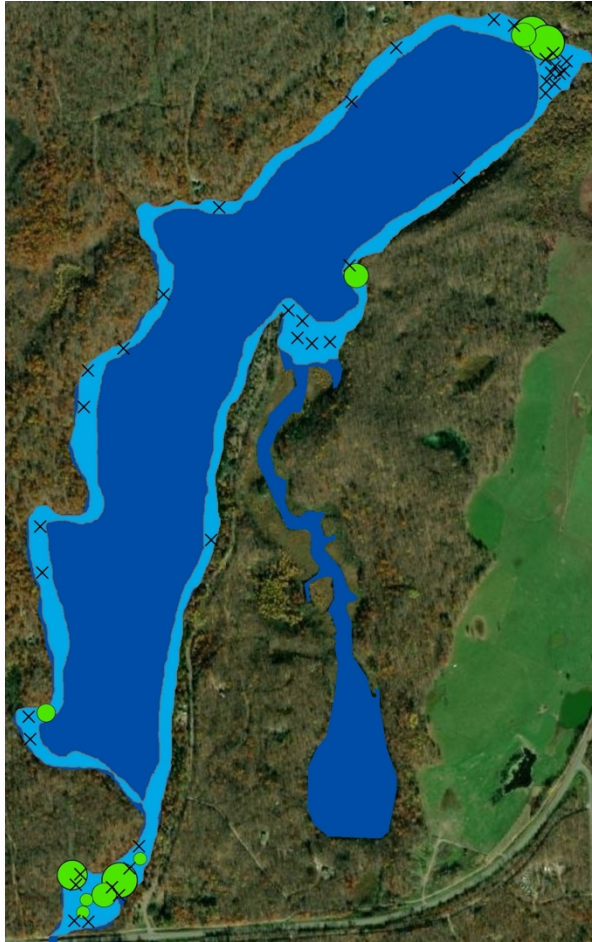
Figure 8. Map of curlyleaf pondweed turion abundance in Balsam and Hemlock Lakes (2021). Estimates of potential for impairment are based upon observed turion abundance and subjective impairment ratings from a previous study (Johnson et al. 2012; see Figures 10 and 11). Note that areas with greater turion abundance are generally the same areas that had higher curlyleaf pondweed density during the June 2021 delineation survey (Figure 5).

The mean turion abundance in previously identified curlyleaf beds (12±7 to 57±25 turions/m²) was roughly 2 times greater than the lake-wide means (Tables 2 and 3). A few isolated locations in each lake had moderate to high turion abundance (generally small bays with soft sediments, Figures 9 and 10) indicating that these locations had a greater potential to support dense curlyleaf growth that could impair local navigation and recreation. However, outside of these isolated areas, turion abundance was very low when compared to other infested lakes.

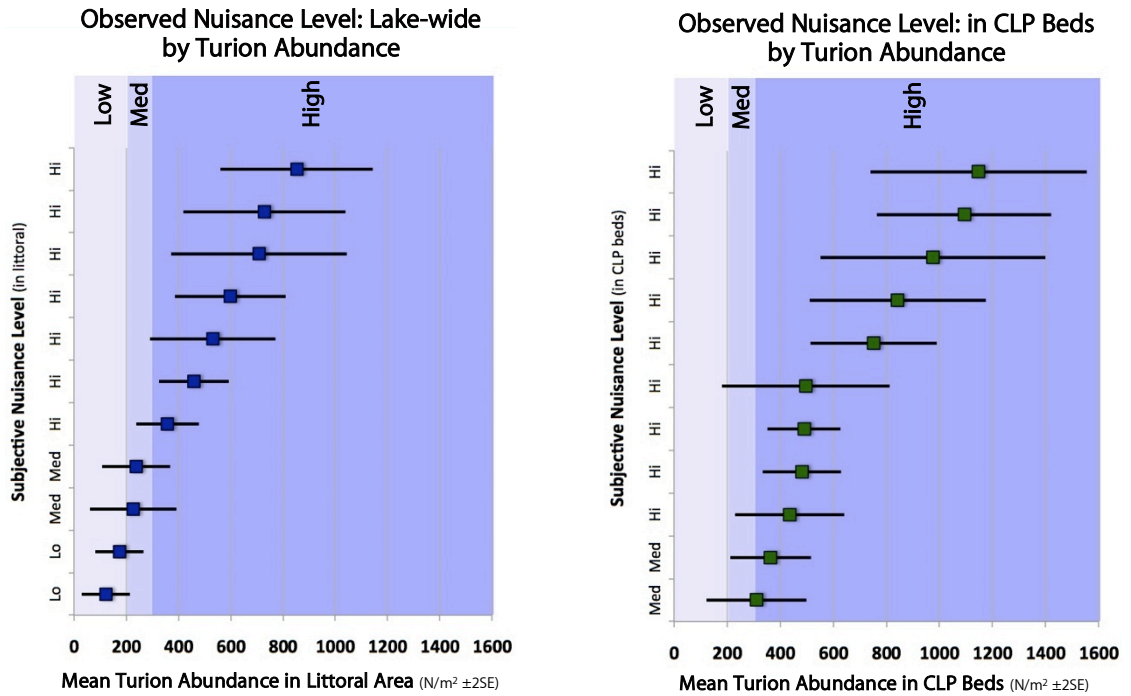
Figure 11. Relationship between turion abundance and curlyleaf pondweed nuisance level (subjectively rated). Nuisance level ratings are based upon the degree to which curlyleaf growth would be expected to impair boating in the area indicated (littoral area or in curlyleaf beds). Means and standard errors (SE) of turion abundance were calculated using data collected in previous studies (Johnson et al. 2012; N~40 in each lake). Error bars represent $\pm 2SE$. These plots are provided to allow comparison of the turion abundance in the Red Cedar Chain to values seen in other infested lakes.
